Pride Home Inspections, LLC.

Pride Home Inspection

Prepared Exclusively For - *John Q Public*

123 Main St

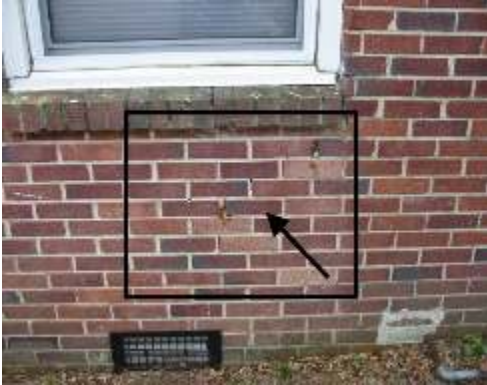
One or more minor cracks (1/8 inch or less) were found in the foundation. These don't appear to be a structural concern, but recommend sealing them to prevent water infiltration and monitoring them in the future.

Rating - REPAIR / MONITOR

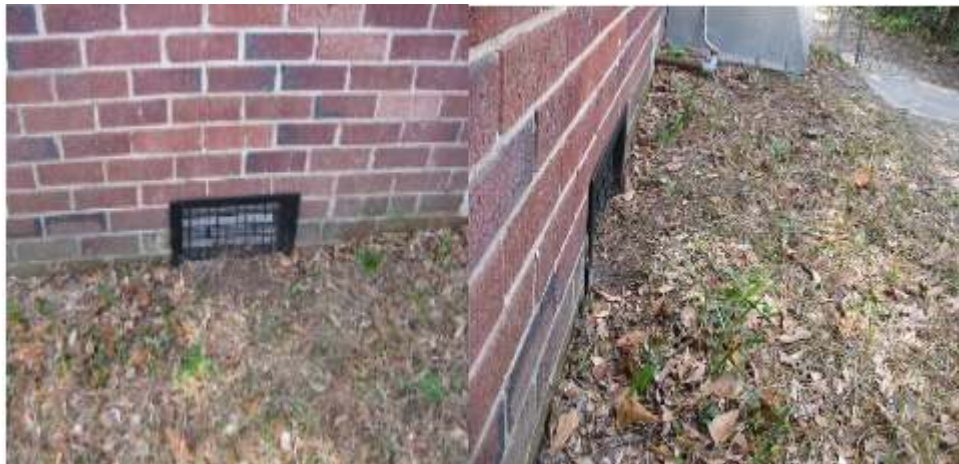
At the time of inspection, The landscape on the side of house towards slopes towards the house right near a vent grate for the crawl space. No Mositure was notice at the time of inspection. This can cause moisture to build up under the house which may cause an insect infestation over time. Recommend monitoring this situation. If situation progresses to cause moisture under the house. Recommend having a licensed contractor evaluate and repair as necessary.

Rating - EVALUATE / MONITOR

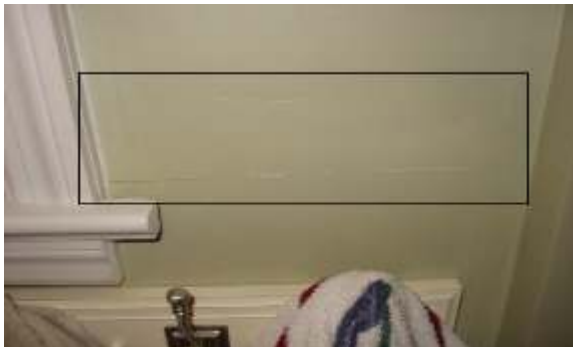
At the time of inspection, The wall in the bathroom had minor bleishes on the wall and ceiling. This is merely a cosmetic issue. Recommend having a license contractor evaluate and repair as necessary.

Rating - COMMENT

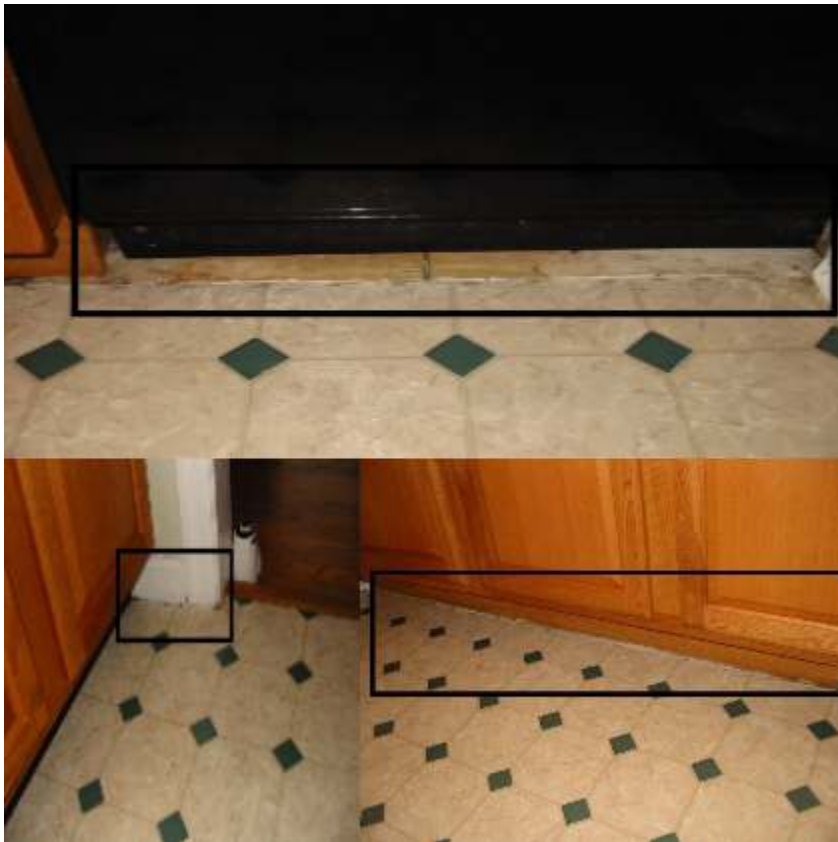
At the time of inspection, The vinyl floor in the kitchen has some shoe mould missing. Recommend having a licensed contractor repair / replace missing shoe moulding.

Rating - EVALUATE/REPAIR

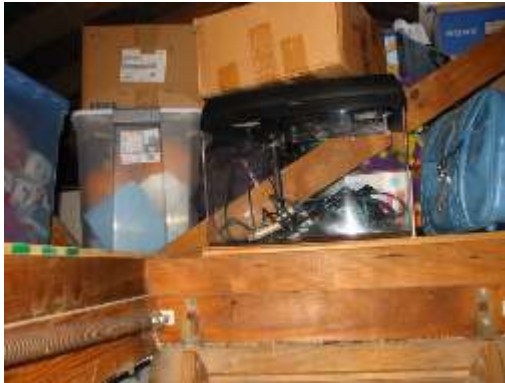
Some attic areas were inaccessible due to stored items, lack of permanently installed walkways, the possibility of damage to loose fill insulation, and/or low height. These areas are excluded from this inspection.

Rating - COMMENT

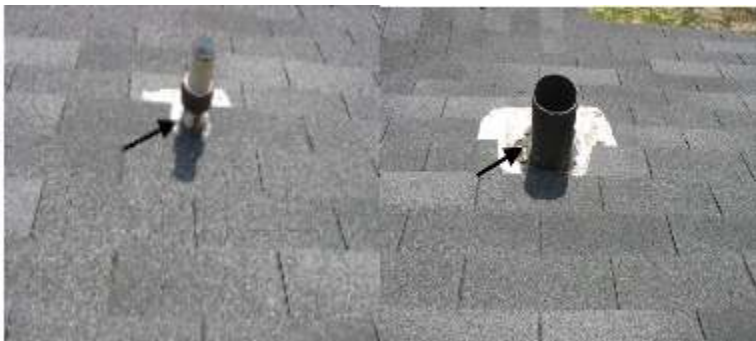
One or more "rubber boot" flashings are damaged or deteriorated and may result in leaks or vermin intrusion. A qualified contractor should replace flashings where necessary.

Rating - EVALUATE/REPAIR

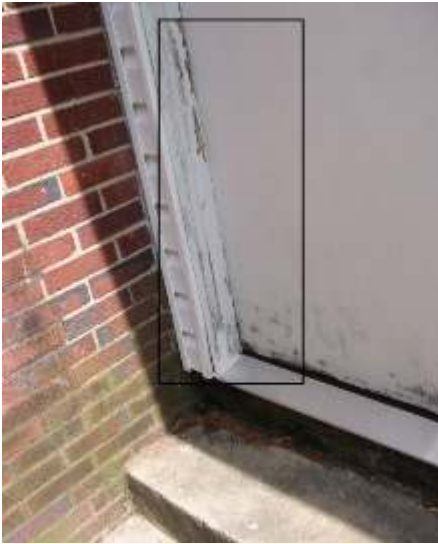
At the time of inspections, The door and door frame at the rear of the structure has signs of rot. Recommend having a licensed contractor evaluate and repair as necessary.

Rating - REPAIR/REPLACE

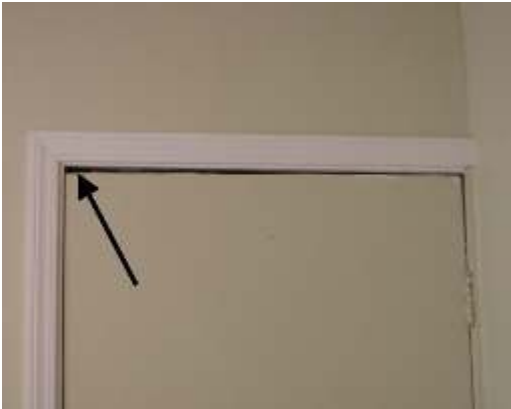
At the time of inspection, The rear door also had about a 1" gap from the top of the door frame. Recommend having a licensed contractor evaluate and repair as necessary.

Rating - EVALUATE/REPAIR

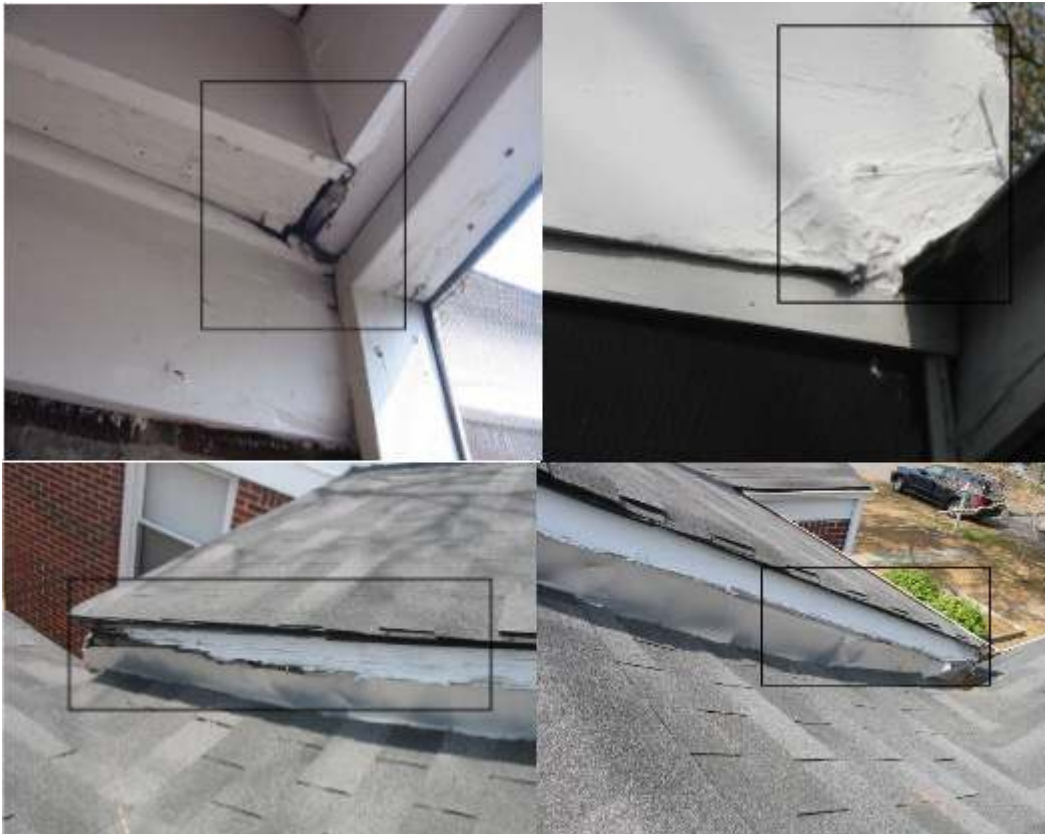
At the time of inspection, There were several areas that have rot on the fascia and exterior trim. Recommend having a licensed contractor evaluate and repair as necessary.

Rating - MINOR DEFECT

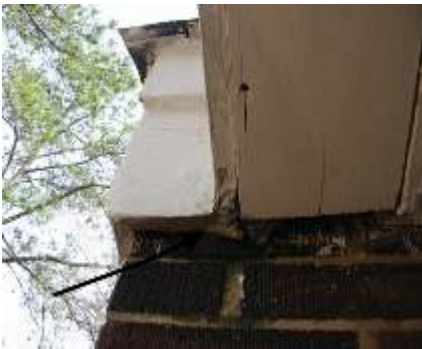
At the time of inspection, There were several areas that have rot on the fascia and exterior trim. Recommend having a licensed contractor evaluate and repair as necessary.

Rating - REPAIR/REPLACE

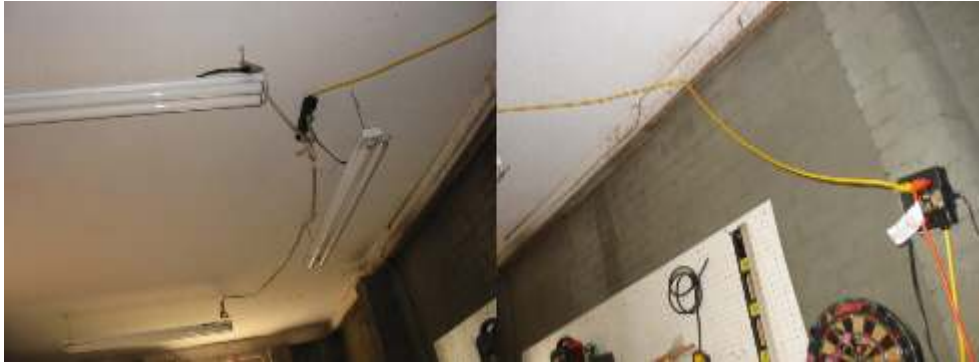
At the time of inspection, There was permanent lighting that was plugged in. This is a safety Hazard. Circuit can over heat or over load heating up and possibly causing a fire. Recommend having a licensed electrician install the lighting permanently

Rating - SAFETY ISSUE / COMMENT
